3.0 FIRE HAZARD ASSESSMENT

4.0 GENERAL SUMMARY: FIRE FUEL HAZARD, STRUCTURAL FIRE ASSESSMENT, AND COMMUNITY PROFILE

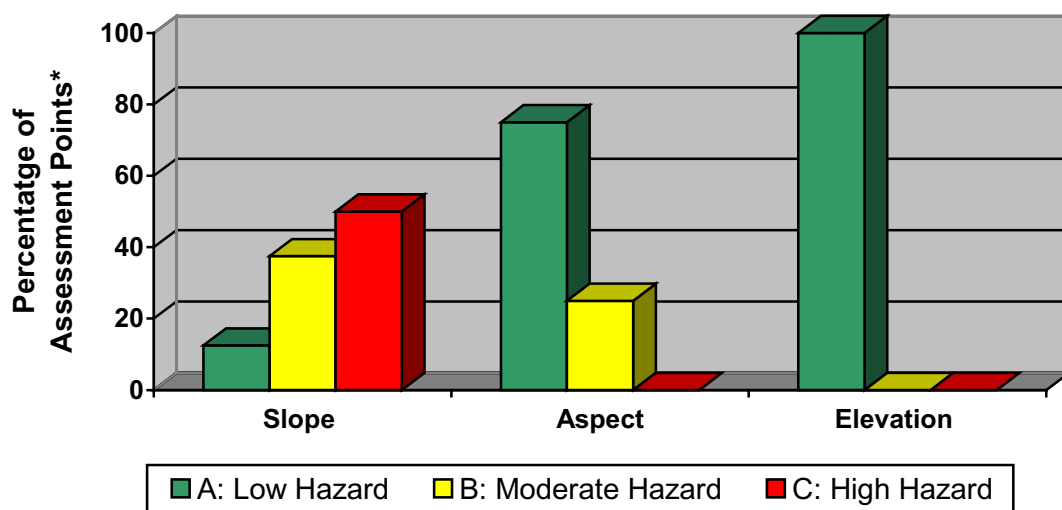
Figure 1: Hoback Ranches Fuel Hazard Assessment Results (Topography)

- **Slope:** 12.5 percent of the survey sites occurred on slopes that were less than 10 percent (Class A). 37.5 percent occurred on moderate slopes (Class B) and 50 percent occurred on steep slopes (class C).
- **Aspect:** 75 percent of the sites had northern exposures (Class A) while 25 percent were on east (or relatively level) facing slopes (Class B).
- **Elevation:** The elevations for all the survey sites were between 7,100 and 8,250 feet amsl (Class A).
- **Fuel Type:** One hundred percent of the fuel survey points had heavy fuels (Class C).
- **Fuel Density:** One hundred percent of the sites had heavy continuous fuels (class C) with moderate to heavy downed-dead woody fuel and an abundance of fir sapling ladder fuels. All were rated as Fire Behavior Fuel Model 10.
- **Fuel Bed Depth:** One hundred percent of the sites had a fuel bed depth of greater than three feet (Class C).

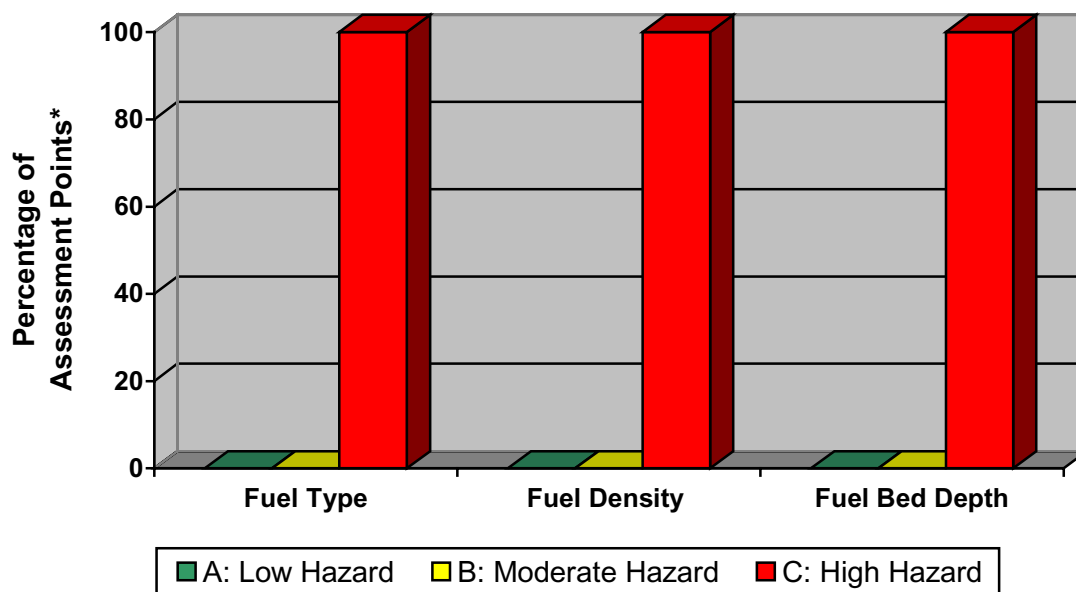
Figure 2: Hoback Ranches Fuel Hazard Assessment Results (Fuels)

In an effort to integrate fuel hazard factors, data for fuel attributes (fuel type, density, and depth) were combined; an aggregate relative risk for each survey point was assigned based on the combination of scores for individual factors. Sites with “C” ratings for all three attributes were regarded as having the highest risk; sites with all “A” ratings, the lowest risk. Results are shown on Map 2. Terrain attributes (slope, aspect, elevation) were aggregated in a manner similar to that used for fuel attributes; these data show clear spatial patterns in terrain in the assessment area (Map 3). Data from the fuels hazard assessment are also depicted on Figures 1 and 2.

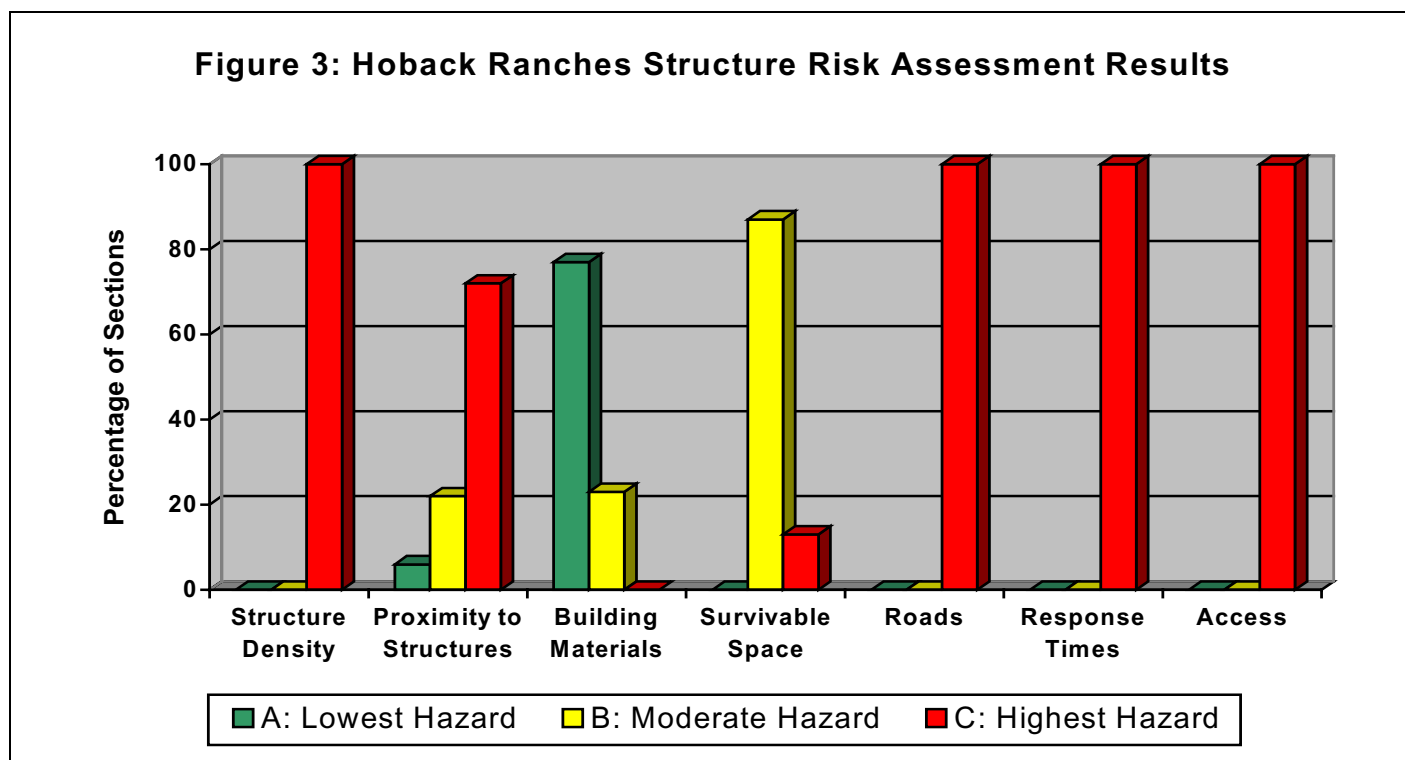
- **Structure Density:** One hundred percent of the sections had less than one structure per 10 acres (Class C).
- **Proximity to Structures:** Of the structures surveyed, 72 percent are rated “high hazard” (Class C), 22 percent are rated as moderately hazardous, with fuels within 40 to 100 feet of structures (Class B), and six percent as low hazard, with fuels greater than 100 feet from structures (Class A).

A combination of data for roads and response times is presented in Map 4. Overall risk is high in many sections not only because of the long response times but also because of the narrow and steep roads. Combined data for structural conditions (proximity to fuel, building materials, presence of a survivable space) is presented in Map 5. The percentages of sections that received a high ranking for the risk assessment to structures in the assessment area are graphically depicted in **Figure 3**.
